Second Five-Year Review Report

Kerr-McGee Chemical Corp. (Soda Springs)
Superfund Site

Caribou County, Idaho

September 2007

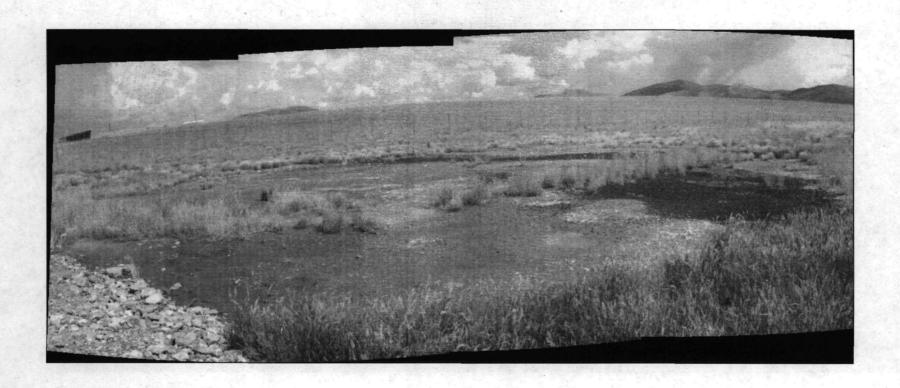
Calcine Cap

The visual inspection of the site for this Five-Year Review confirmed that the condition of the caps were still able to provide the protectiveness required by the ROD. Repairs made to the calcine cap to address erosion issues, including replacing topsoil, were effective and no additional work is necessary.

Some erosion occurred on the calcine cap during the first growing season and was addressed during the First Five-Year Review period. This prompted Tronox, Inc. to construct the infiltration ponds and snow fences. The snow fences were installed to minimize snow drifting into the ponds, thus reducing the amount of water to manage on the site.

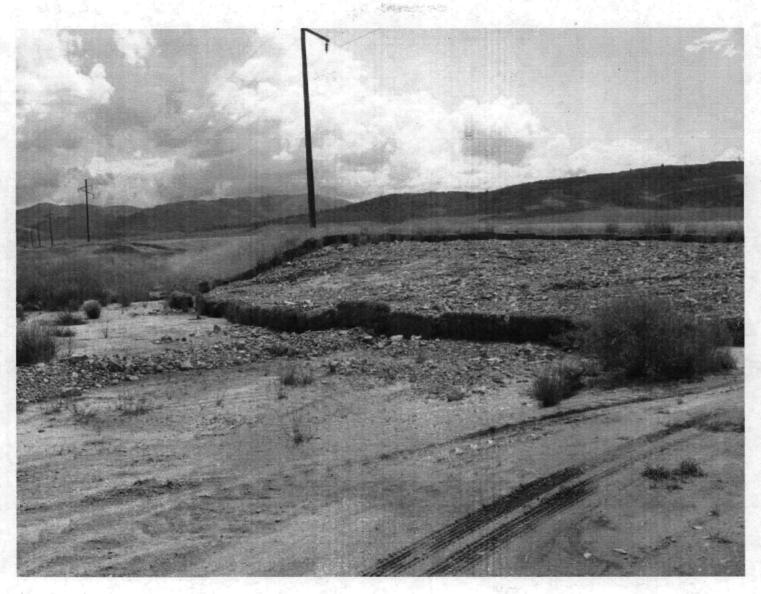
Infiltration Pond

In 2002, an infiltration pond was constructed on the north side of the calcine containment area to capture precipitation runoff from the cap. In 2004, another infiltration pond was completed on the south side of the cap. After observing snow drifts piling on the cap and increasing the amount of percolation through the cap, a snow fence was erected along the south side of the facility, in line with the cap.
